DAMAGE PROFILES IN SILICON AND THEIR IMPACT ON
DEVICE RELIABILITY

G. H. Schwuttke

International Business Machines Corporation

TECHNICAL REPORT No. 7, Part I
January 1976

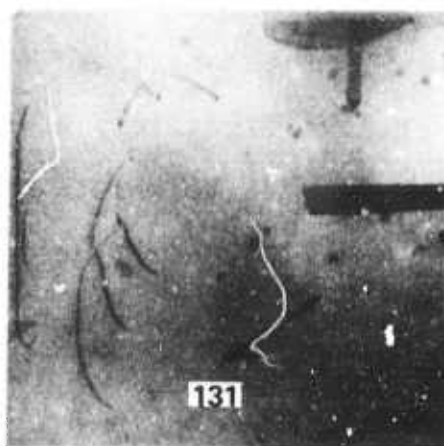
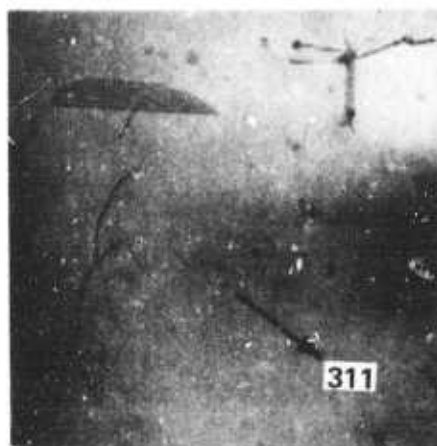
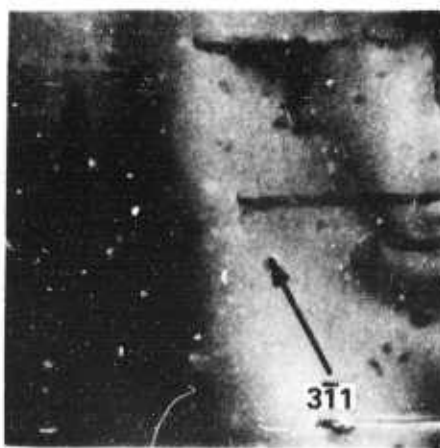
Fig. 25. TEM micrographs of oxidation stacking faults taken with (e) 131, (f) 311, (g) 311, and (h) 131 reflections.

is an $a/3$ ($\overline{111}$) Frank partial. Each possible Shockley is excluded by a micrograph taken with one of the (113) reflections, e.g. Burgers vector (B.V.) $a/6$ $[112]$ is excluded by the $(\overline{1}3\overline{1})$ and $(3\overline{1}\overline{1})$ reflections (Fig. 25c,d); B.V. $a/6$ $[\overline{2}1\overline{1}]$ is excluded by (131) (Fig. 25e); and B.V. $a/6$ $[1\overline{2}\overline{1}]$ is excluded by (311) (Fig. 25f). Since contrast is seen for the dislocation line in all cited reflections the partial dislocation is identified as a Frank partial. In addition for $g.b = 0; \pm 1/3$ it can be observed that the line contrast is weak when the g-vector is more or less parallel to the line direction and that the line contrast is strong when the g-vector is perpendicular to it. It follows that for $(\overline{2}20)$, $(3\overline{11})$ and $(1\overline{3}1)$ reflections (Figs. 25e,f) assuming $b = a/3$ ($\overline{111}$), the line contrast is weak, if $g.(b \wedge u)$ is small, because $g.b = 0; \pm 1/3$, but that the line contrast is strong when $g.(b \wedge u)$ reaches larger values. This confirms again that the bounding partial dislocation is of the Frank type.

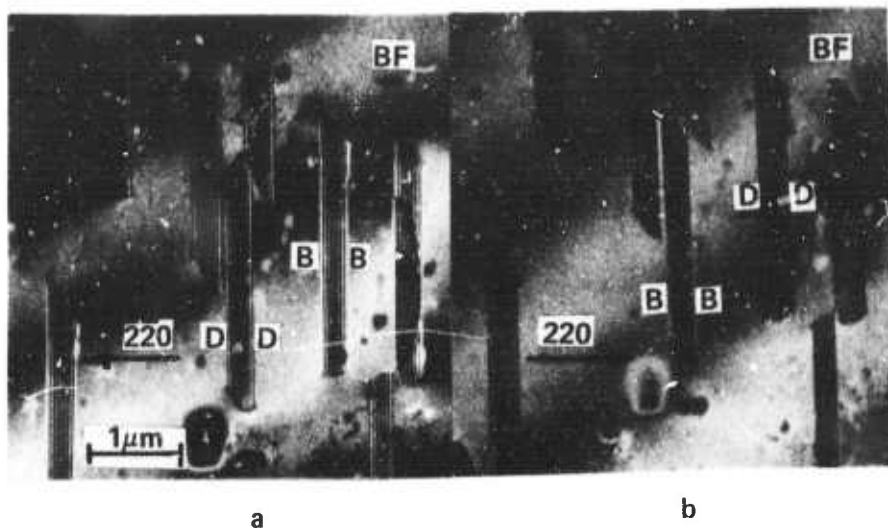
Fig. 26. Bright field TEM micrographs of the same stacking faults with opposite operating g -vectors and $S = 0$ to determine the nature of the fault. (a) $g = \bar{2}20$, (b) $g = 220$.

dislocation inside the bulk material has a round shape. During the thinning process for the TEM preparation parts of these round dislocations are cut off. However in most cases it is easy to recognize the top of the defect by looking at the partials. The specimen is inserted into the TEM with the non-etched side up. Depending on fault inclination the fault shows, respectively, bright or dark outer fringes (Fig. 26a). The fringe contrast is reversed when the opposite g-vector is used (Fig. 26b). Using well established rules^{8,13,14} the nature of the fault can be determined from a bright field image alone (Fig. 26). It follows that this type of stacking faults is extrinsic. Figure 27 shows another set of bright and dark field images of the same faults. Here the change in fringe contrast at the bottom can also be observed and thus each micrograph can be used to determine the extrinsic nature of the faults.¹⁴ It follows, again, that oxidation induced stacking faults are extrinsic.

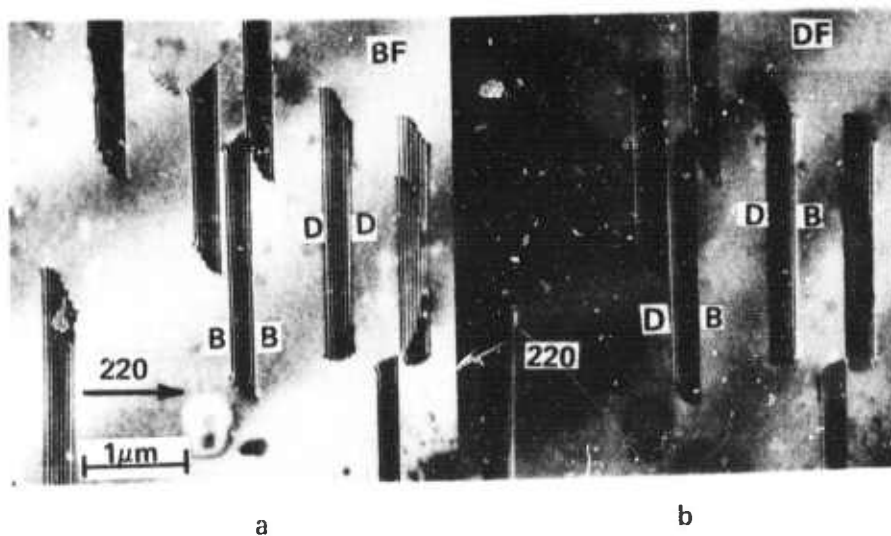
Fig. 27. TEM micrographs to show the contrast change of the outer fringes and to determine the nature of the stacking faults. (a) Bright and (b) dark field.

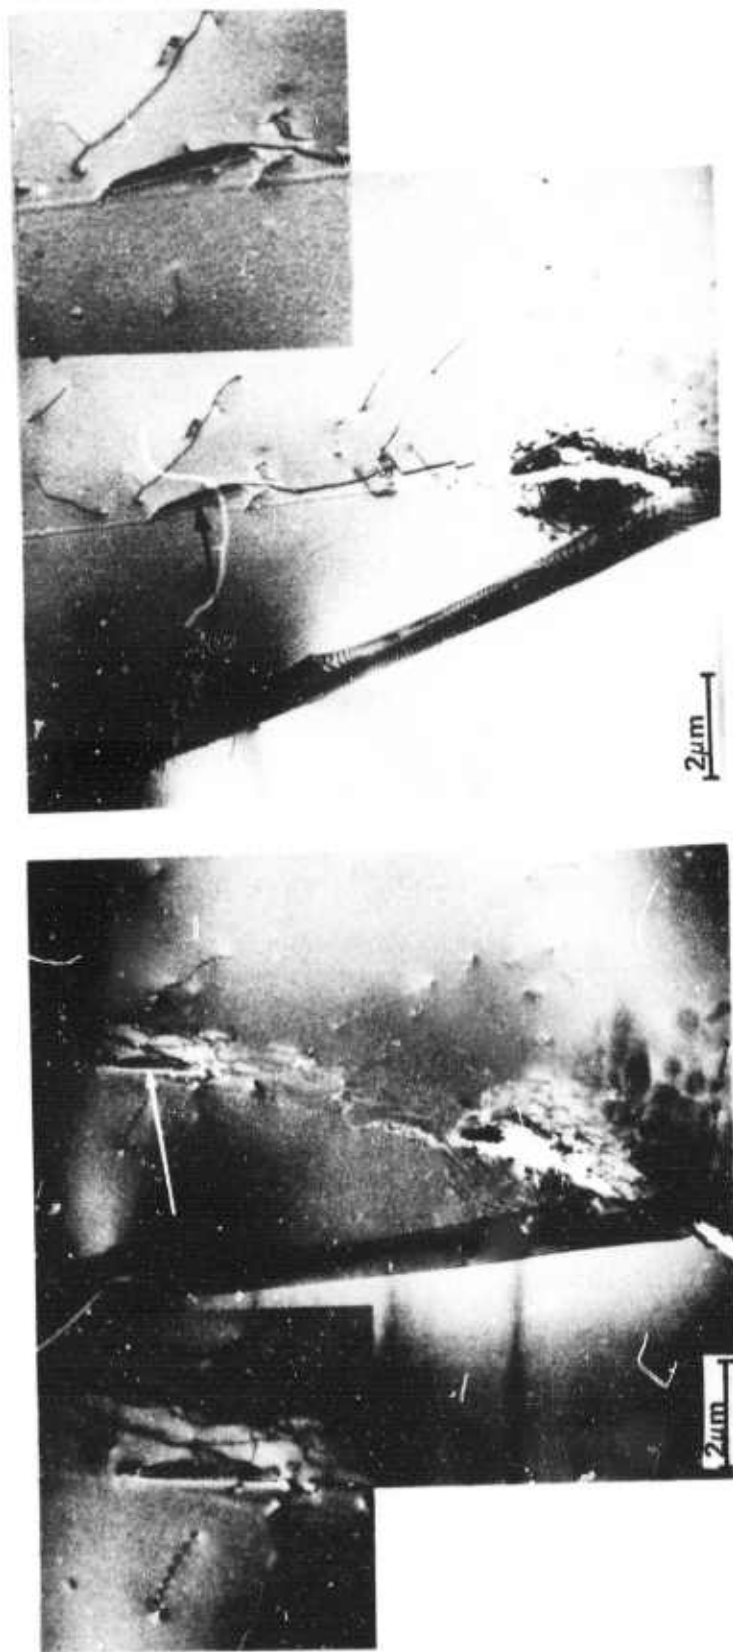
Fig. 28. TEM micrograph of fracture cone showing (a) dislocations after first annealing in oxygen. Note direct correlation between split and stacking fault observed at split site after second oxidation (b). Position of split and stacking fault marked in micrographs.

Further, it also becomes clear that microcracks can be annealed, specifically, if such splits are in the (111) plane. Assuming that block slip governs crack formation it appears plausible to assume that bonding between the silicon atoms in the vicinity of the crack tip is re-established through high temperature relaxations. Thus fairly large crack areas (micron range) can heal and 60° - and 90° - dislocations are the healing product of this process. Submicron cracks cause a much smaller displacement between the split crystal parts and stacking fault nucleation may occur directly through rebonding of the silicon atoms if the displacement "R" of the free crystal surfaces is of the right order of magnitude. This is shown very clearly in the TEM - micrograph of Fig. 28.
